# CONNEAUTTEE CREEK MITIGATION BANK

## MITIGATION SITE PLAN

JUNE 2013

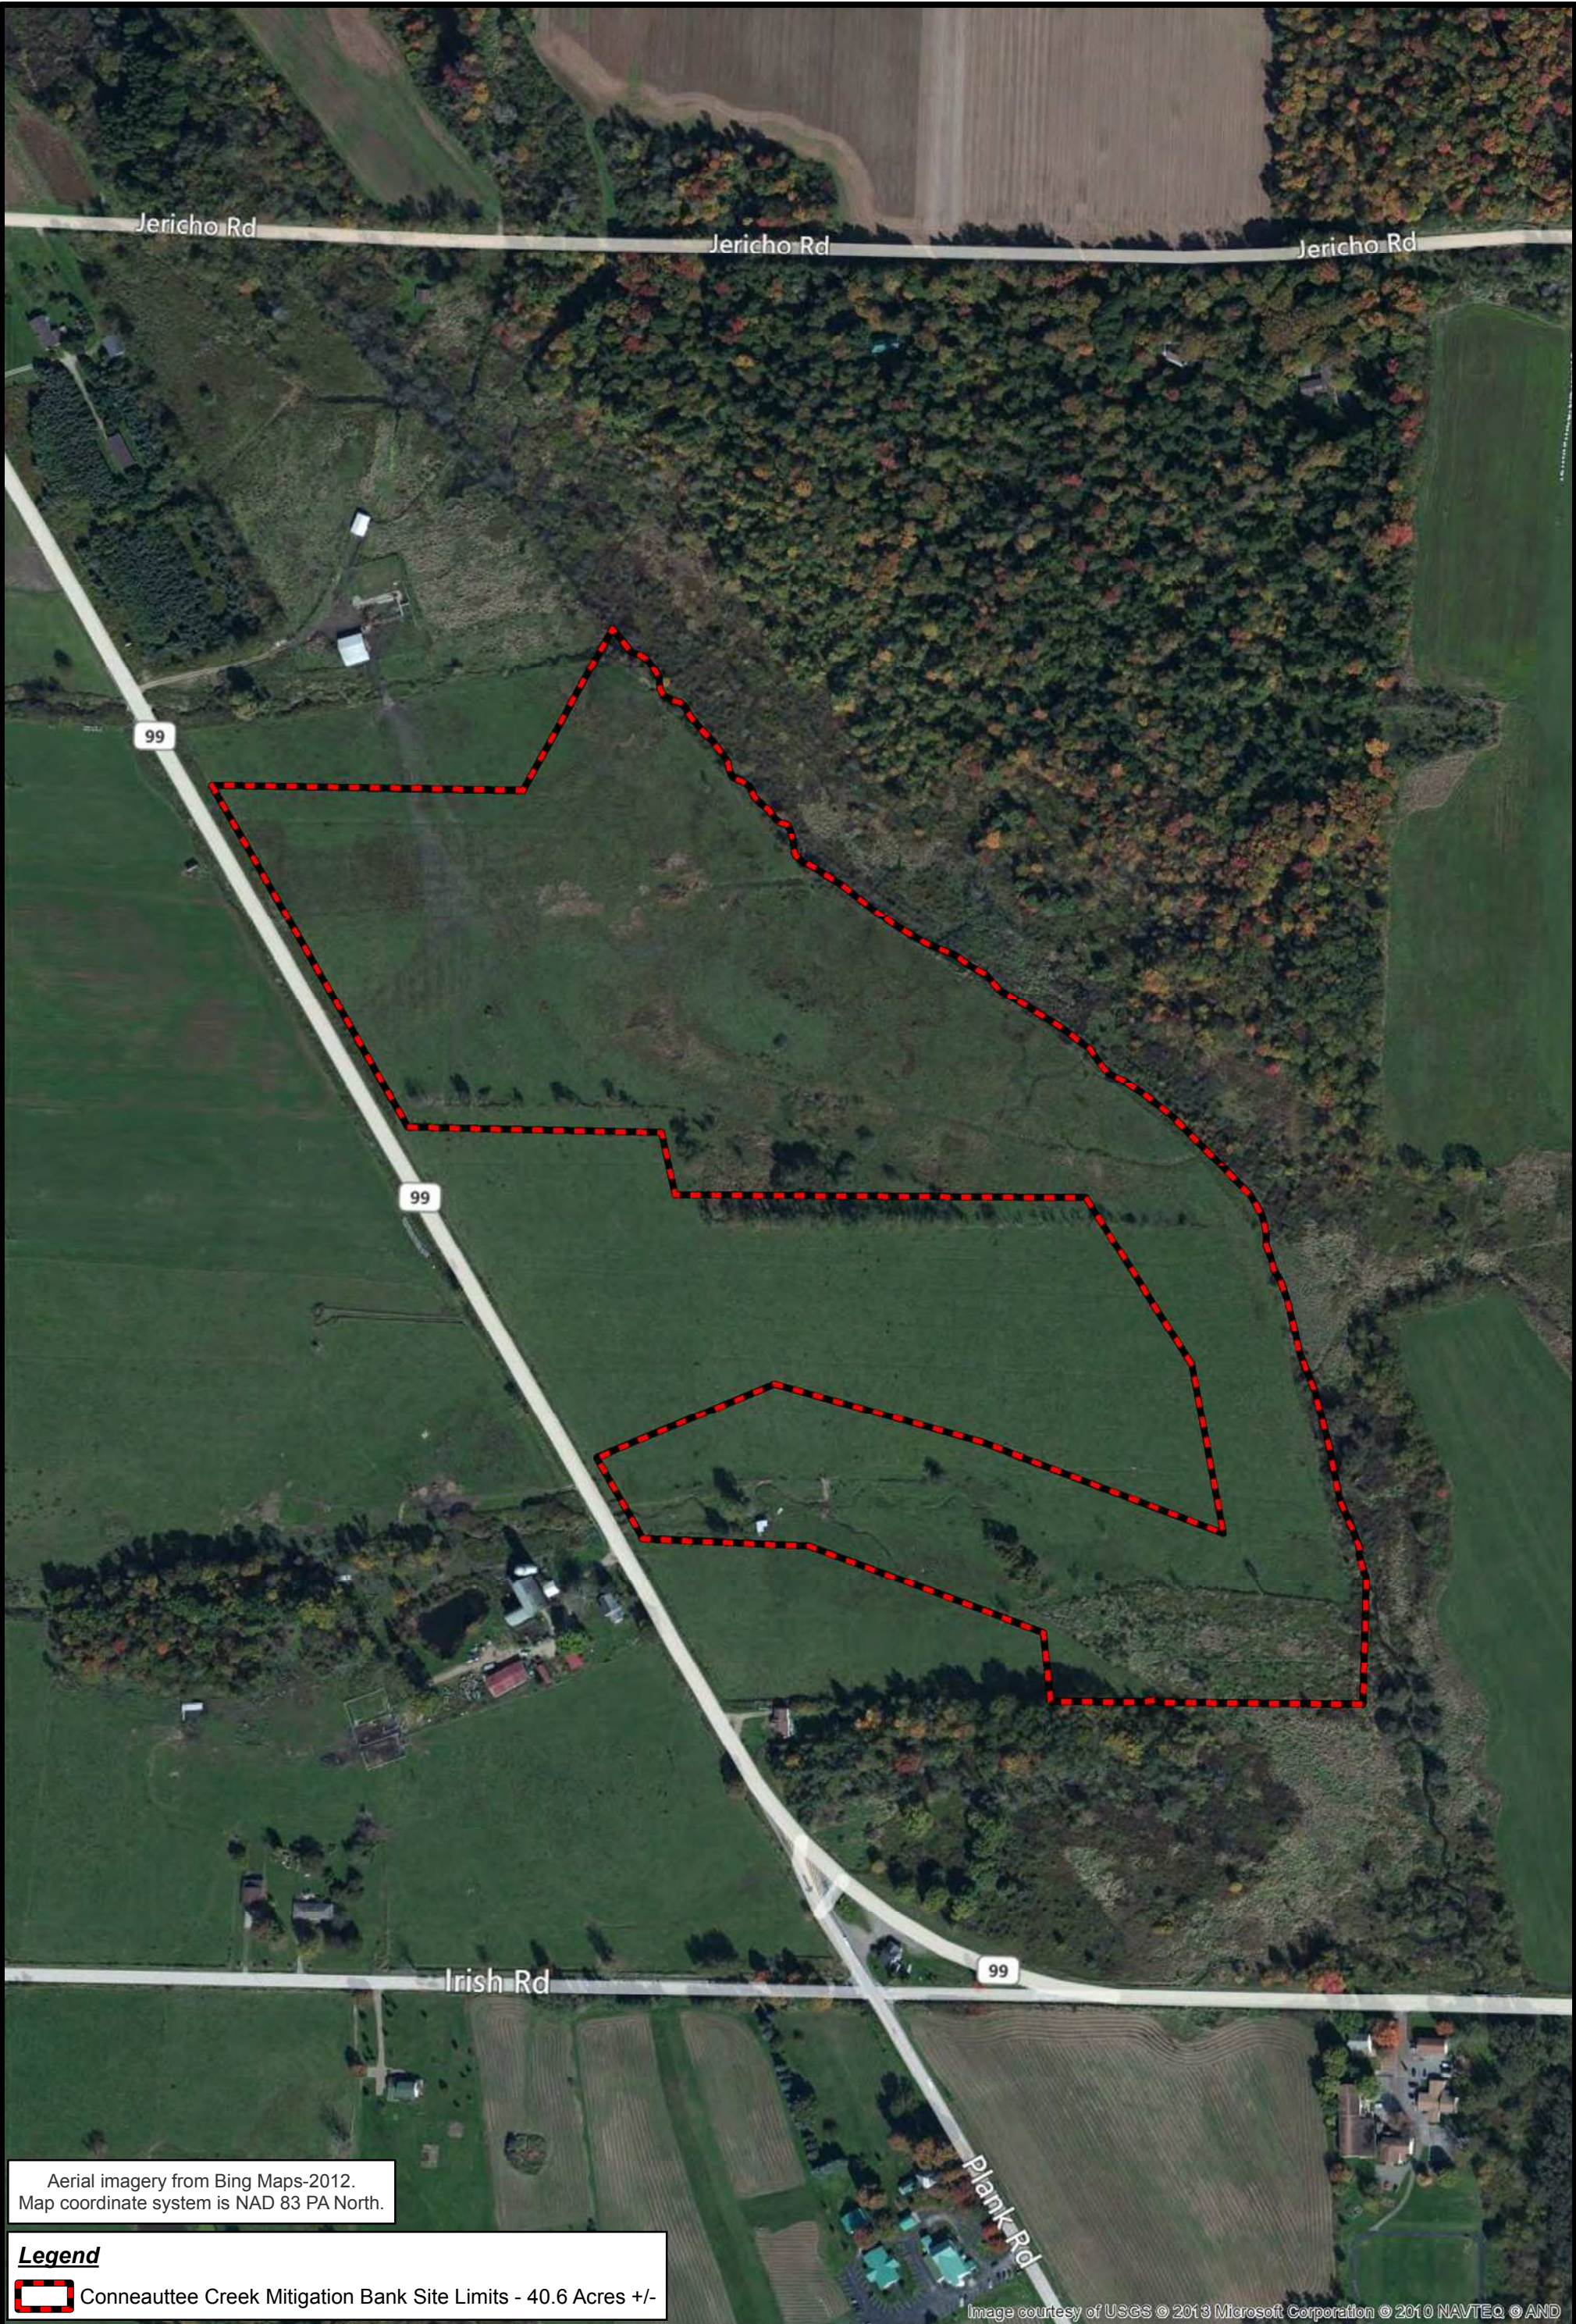
CONNEAUTTEE CREEK MITIGATION BANK  
EXISTING CONDITIONS AERIAL MAP  
CRAWFORD COUNTY, PENNSYLVANIA

**Legend**  
Conneauttee Creek Mitigation Bank Site Limits - 40.6 Acres +/-

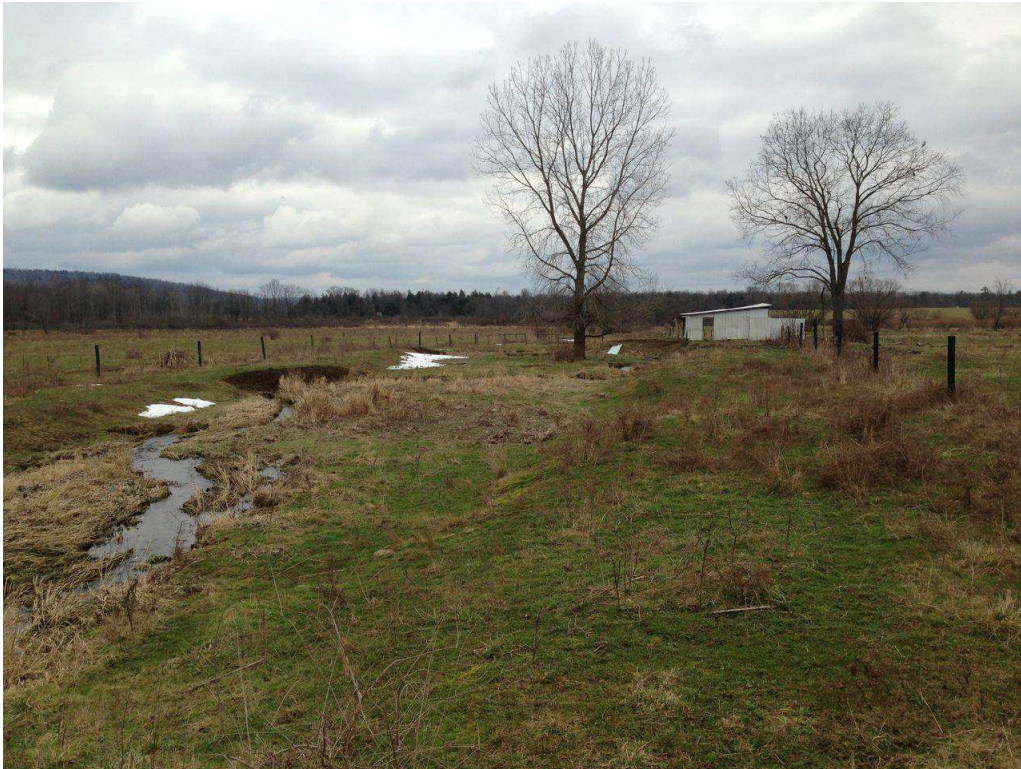
Photo 1 - Unnamed tributary of Torry Run lacks a forested buffer as it flows through pasture on the proposed Project Site. (1/21/13)

The CCMB contains two streams: Torry Run and an unnamed tributary to Torry Run. The unnamed tributary onsite originates from small headwaters which discharge through one main channel within the CCMB. The unnamed tributary exists in a degraded condition as a result of anthropogenic alterations. A failed cattle crossing guard blocks the flow of water along the historical stream route. This impediment redirected the stream flow to form a new channel in an adjacent field. The unnamed tributary of Torry Run lacks a forested buffer, as well as stream bank stabilizing vegetation, as it flows through pasture on the Bank Site. The banks along the unnamed tributary are actively eroding and sloughing.

Torry Run flows along the northern border of the Bank Site. Torry Run lacks stabilizing stream bank vegetation, and both Torry Run and the unnamed tributary to Torry Run lack forested riparian corridors. Most of the riparian corridors consist of actively grazed field, which lack both a tree and shrub layer. In this degraded condition, this system offers limited available aquatic and terrestrial habitat, is a major source of sediment, and contributes to poor water quality downstream.

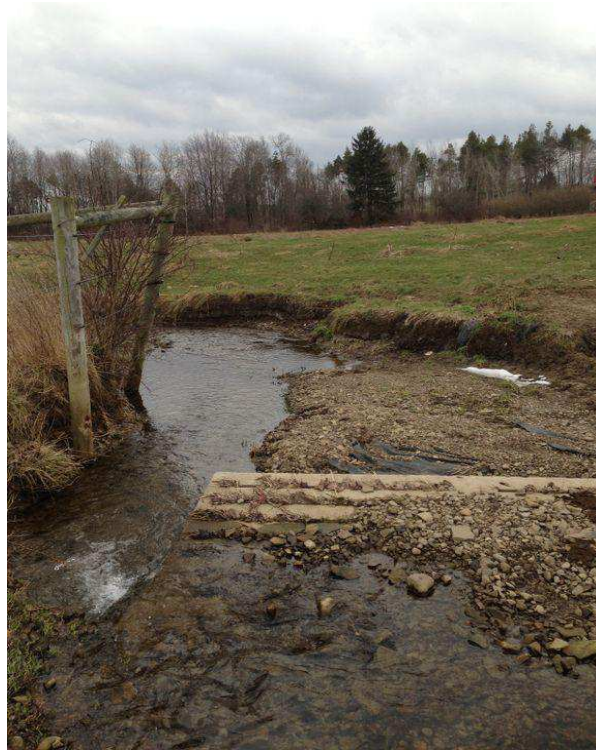
Photo 3 – Cattle crossing guard that has failed and redirected flow to form a new channel in an adjacent field. (1/21/13)

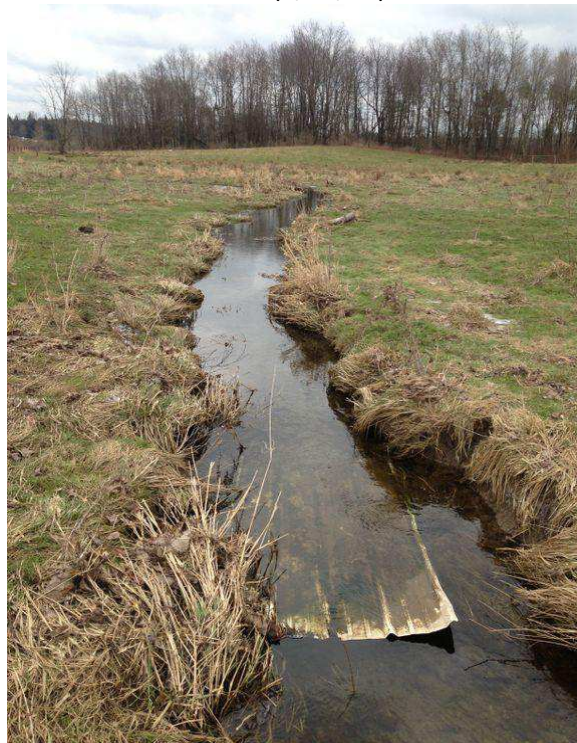
Photo 4 – Unnamed tributary in its existing condition has limited habitat for aquatic species. (1/21/13)

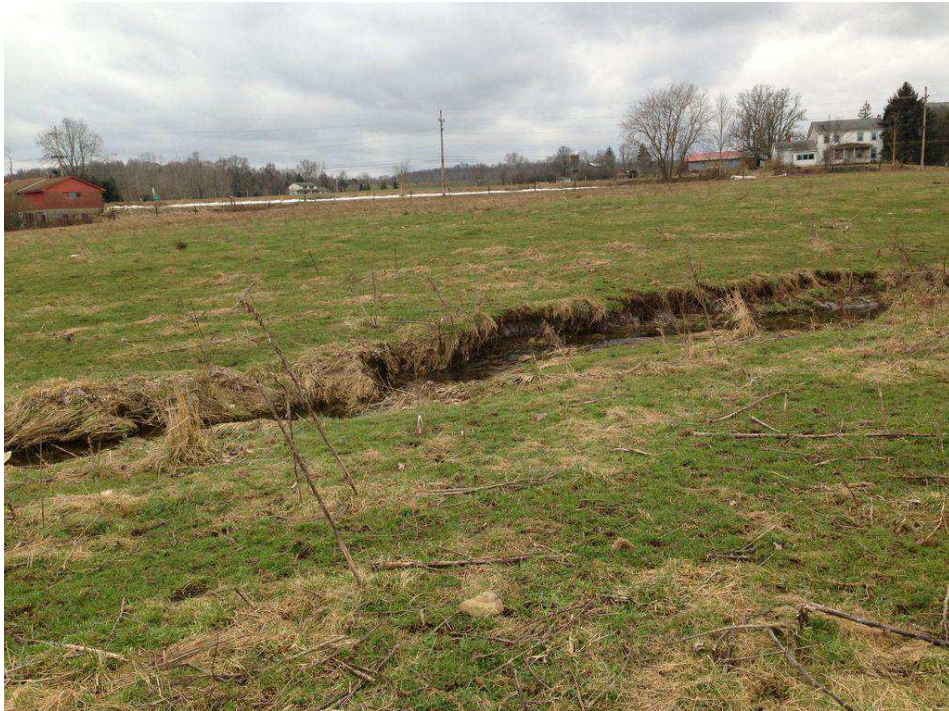
Photo 5 – Banks along unnamed tributary are actively eroding and sloughing. (1/21/13)

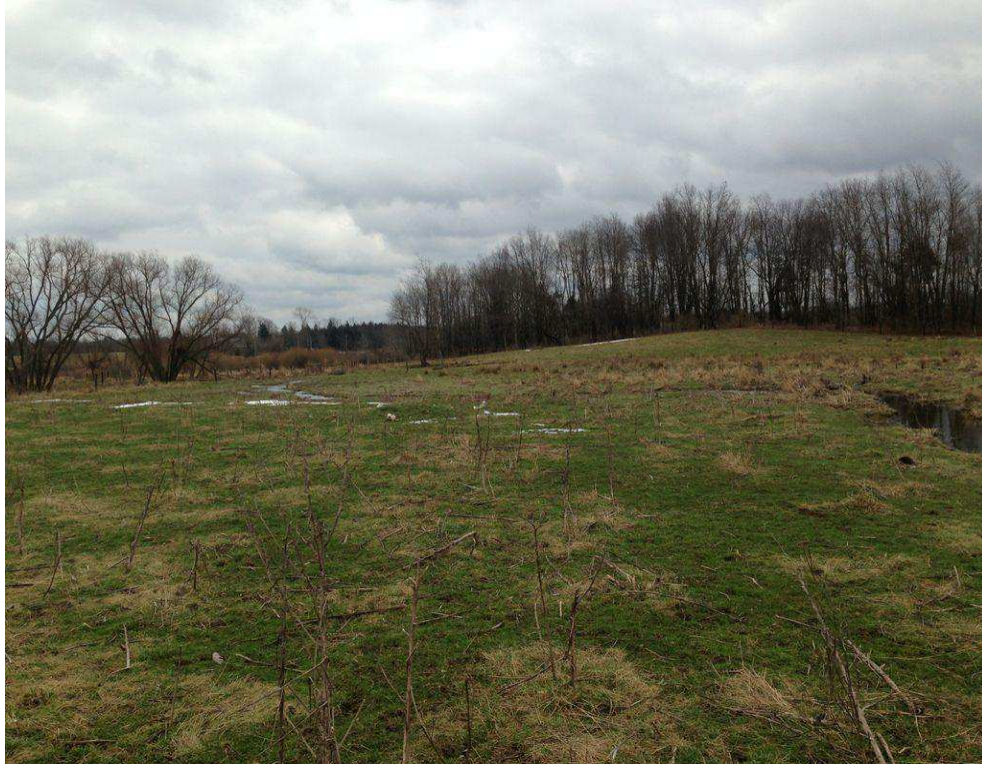
Photo 6 – Riparian zone of unnamed tributary and PEM are currently used as pastures for the production of livestock. (1/21/13)

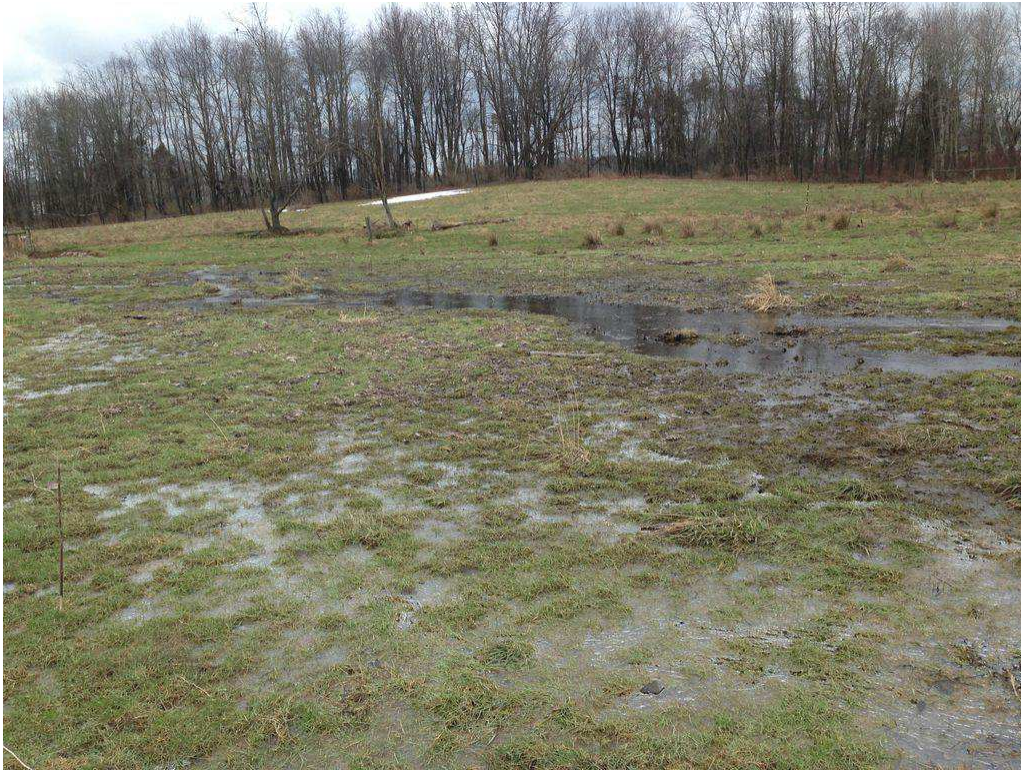
Photo 7 – Flooding of the unnamed tributary provides hydrology to the adjacent degraded PEM wetland.  
(1/21/13)

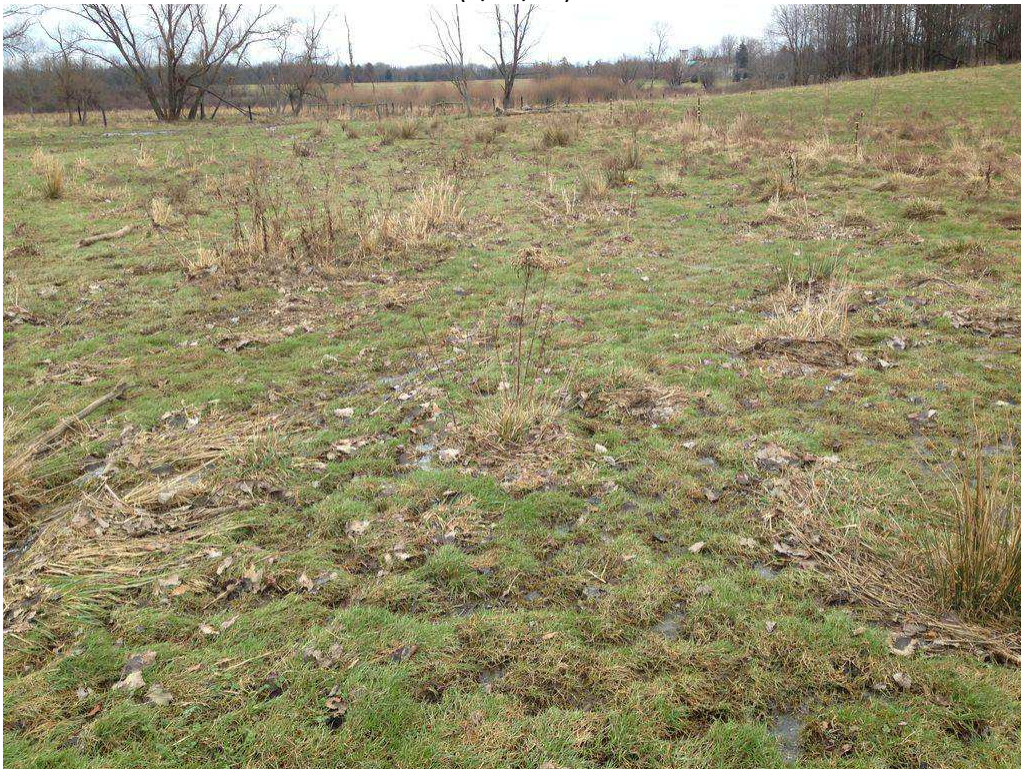
Photo 8 – Rack lines present in a degraded PEM wetland system. (1/21/13)

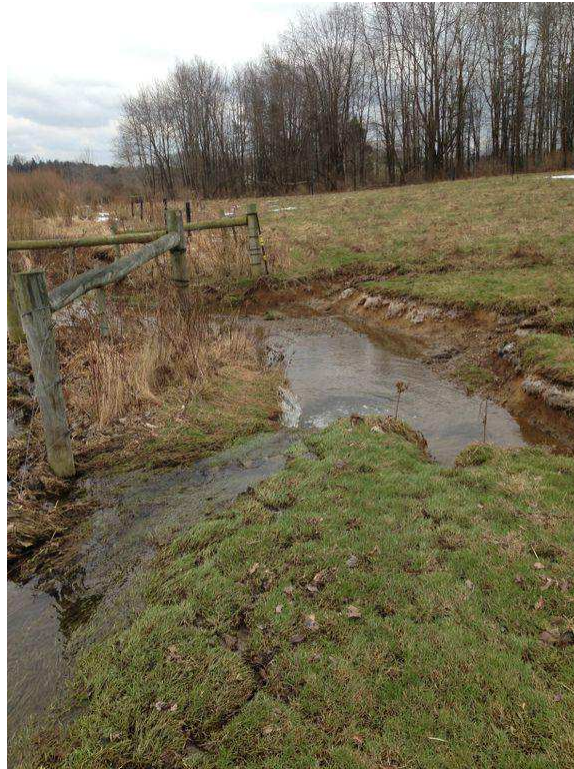
Photo 9 – Hydrology from historical channel joins current channel forming a pool at a livestock crossing.  
(1/21/13)

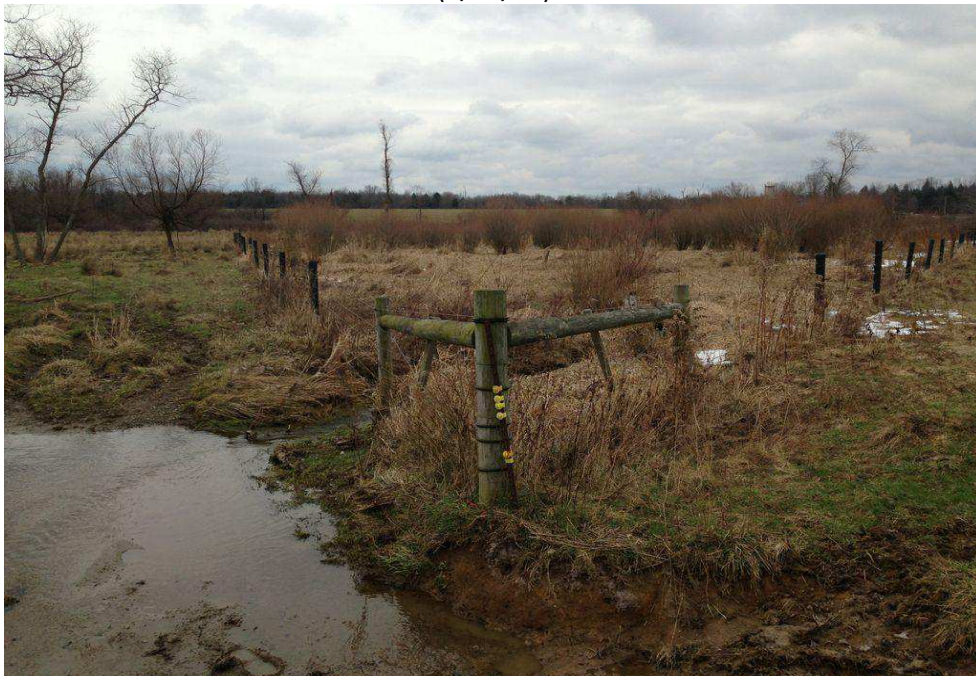
Photo 10 – Direct access to the unnamed tributary from cattle has caused degradation of the resource.  
(1/21/13)

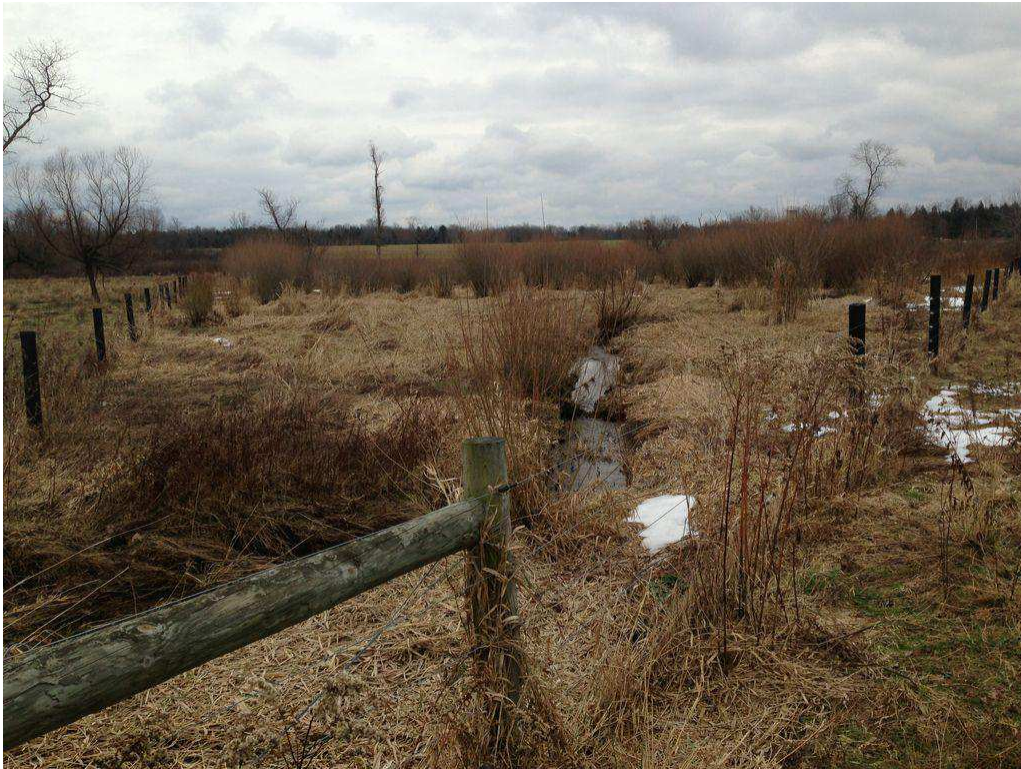
Photo 11 – Tributary enters a scrub/shrub community where livestock is currently excluded.  
(1/21/13)

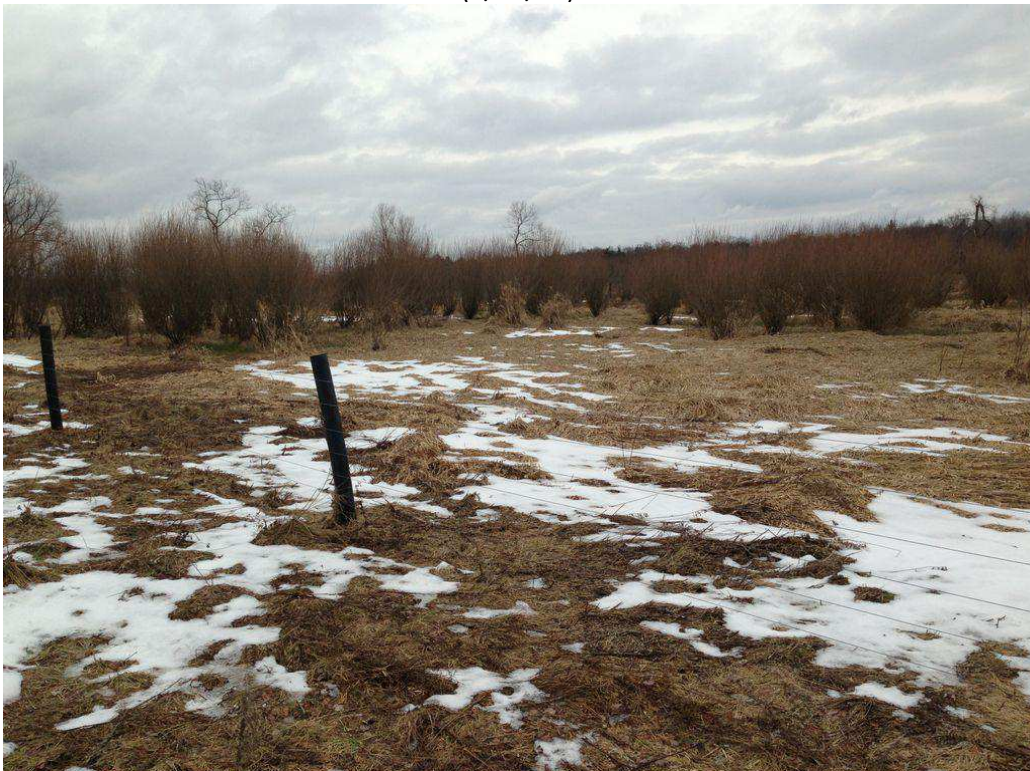
Photo 12 – Various shrubs and reed canary grass dominate the riparian community. (1/21/13)

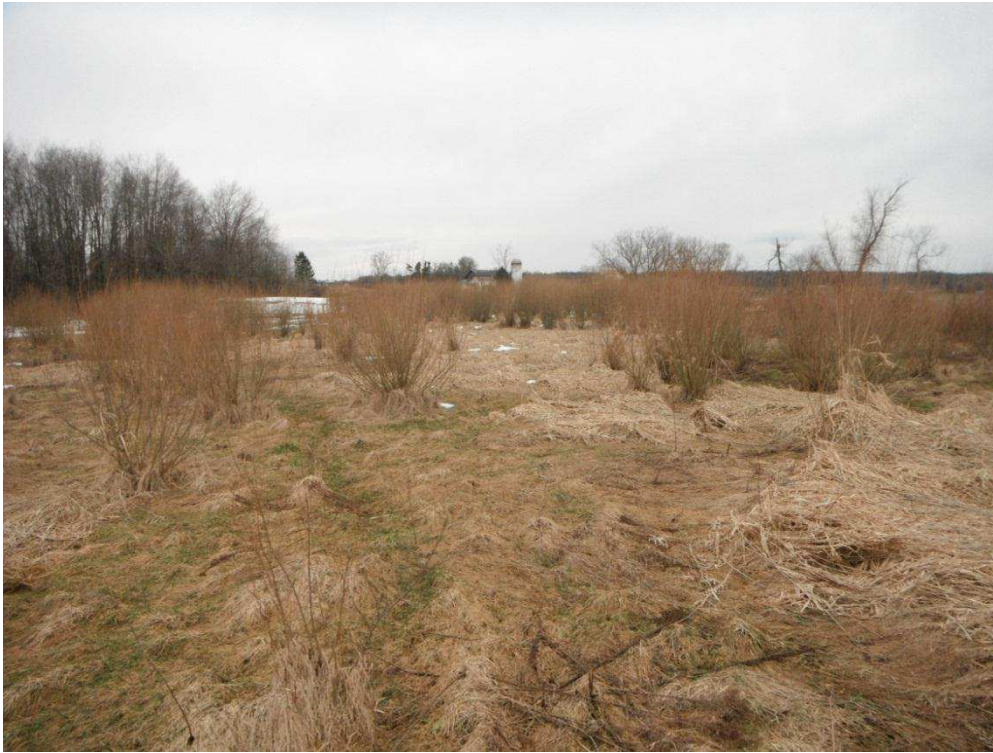
Photo 13 – Various shrubs and reed canary grass dominate the riparian community.  
(1/21/13)

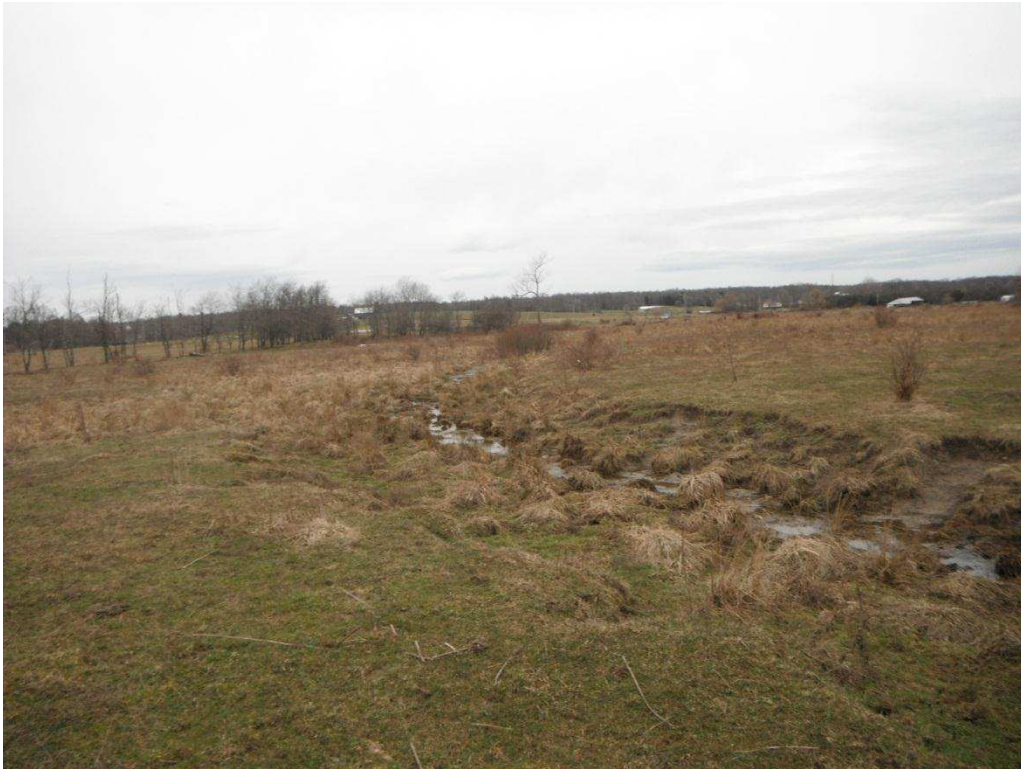
Photo 15 – Drainage feature from PEM wetlands to Torry Run within pastured field. (1/21/13)

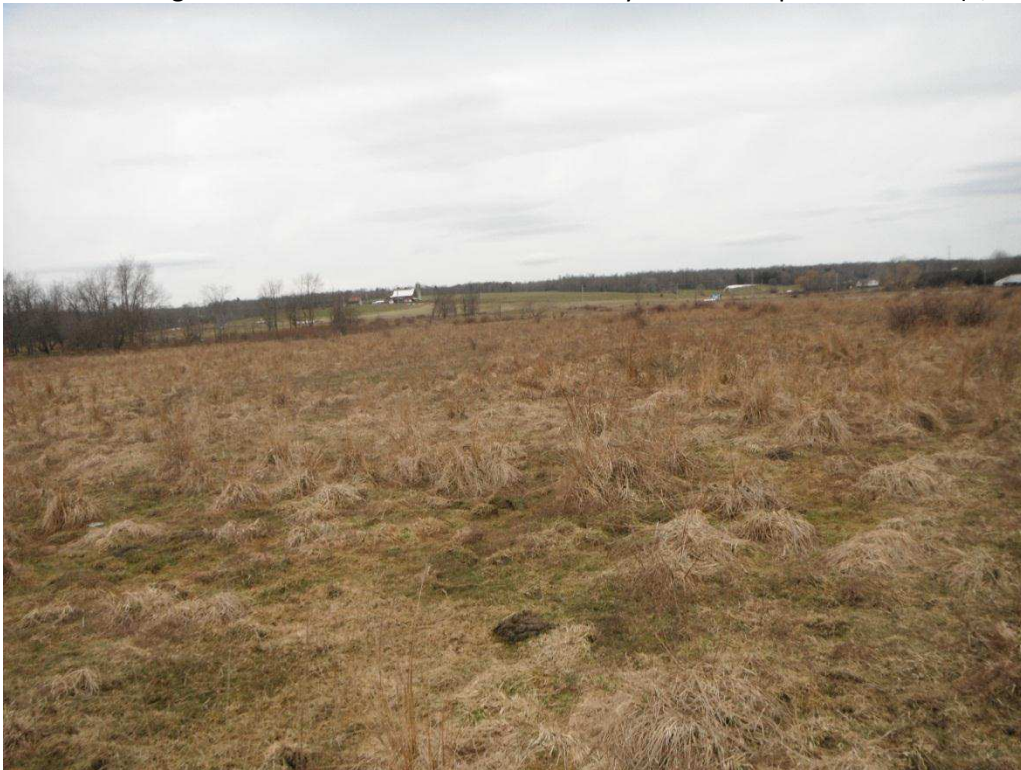
Photo 16 – PEM wetlands to be restored to PFO wetlands. (1/21/13)

Wetland restoration is proposed for existing and degraded PEM dominated wetlands within the CCMB. Currently, these wetlands are actively grazed, directly accessed by livestock, and lack both tree and shrub coverage. These restoration efforts are proposed for 27.9 acres of wetlands. Enhancement is also proposed for 3.2 acres of PSS wetlands within the CCMB that lacks a diverse vegetation community and includes a presence of invasive species (reed canary grass) that will be managed to establish control and restoration to native species.

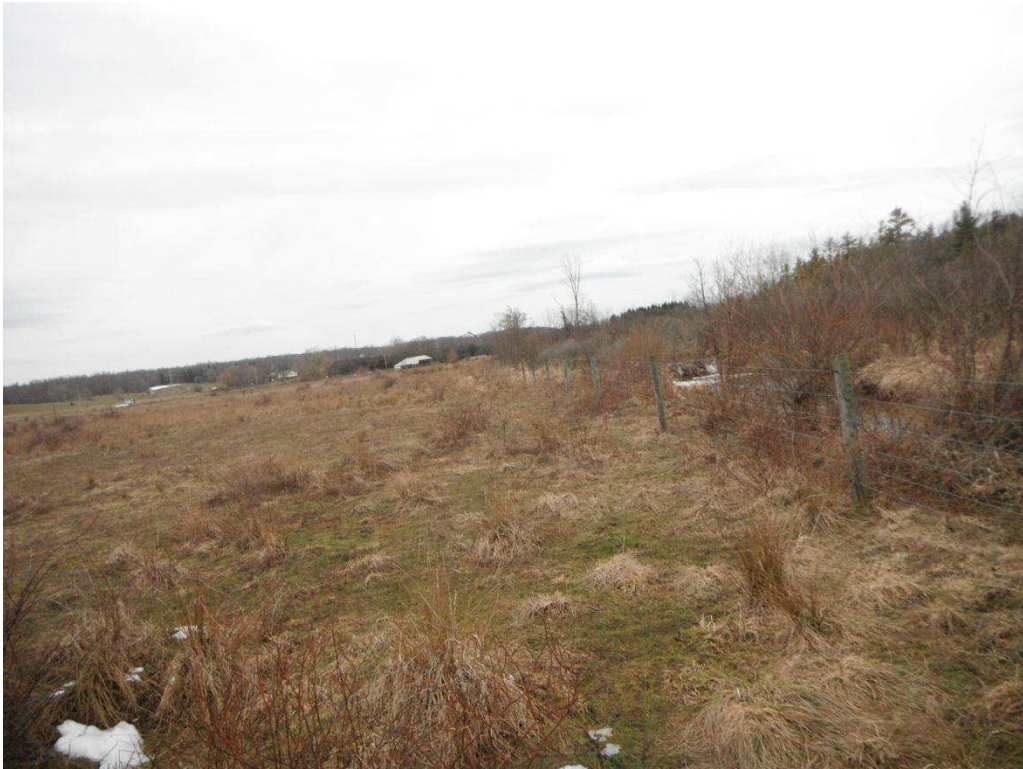
Photo 17 - Riparian buffer of Torry Run lacks a sufficient tree and shrub layer to filter nutrients from adjacent uplands. (1/21/13)

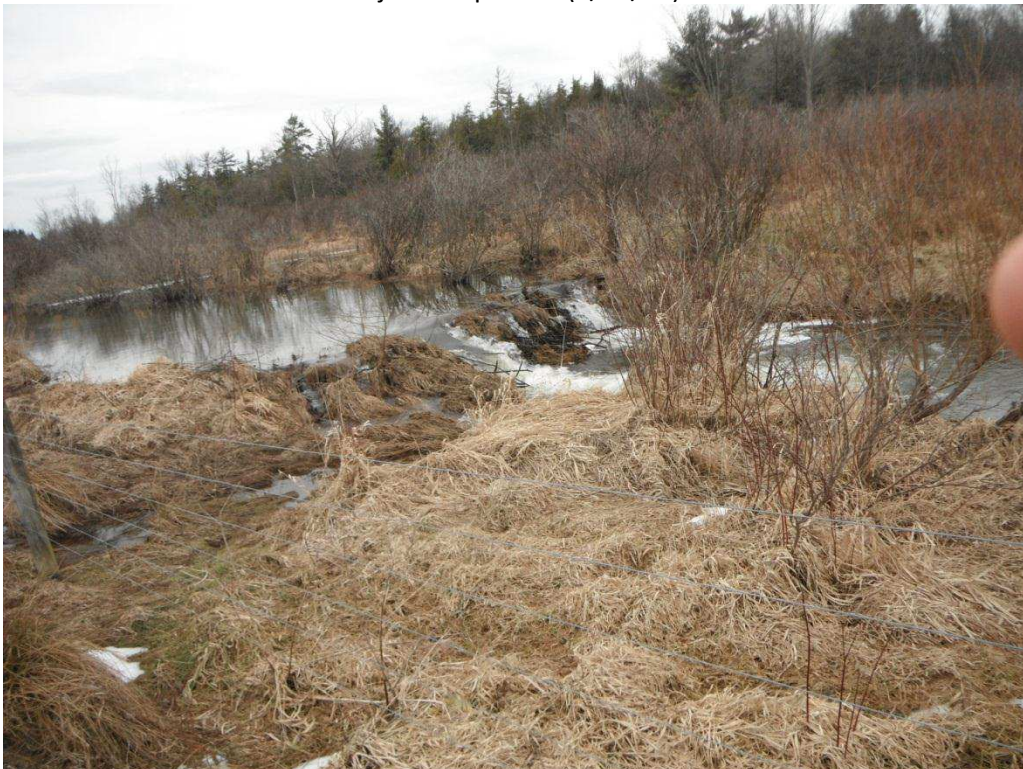
Photo 18 – Beaver dam on Torry Run. (1/21/13)

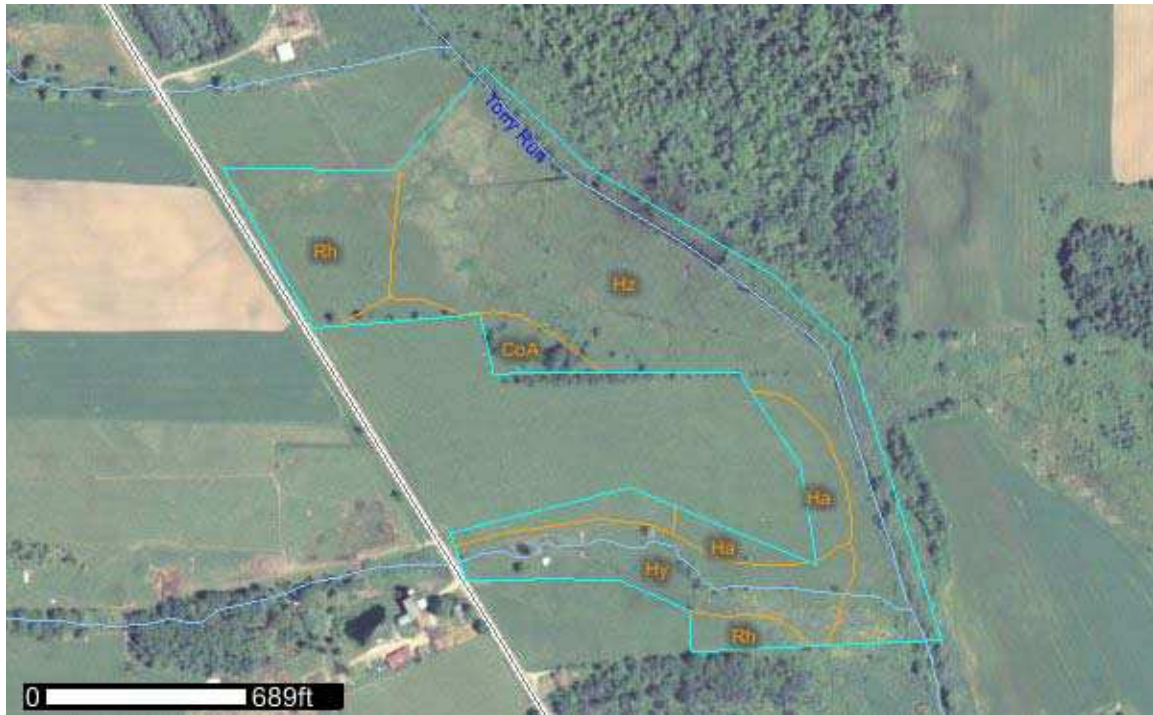
Figure 6. Site soil map, from NRCS website.

Holly silty clay loam (Hz) is the primary soil identified within the Site covering approximately 58% of the central, eastern, and southeastern portions of the Site (Figure 6). Holly silt loam (Hy) is identified within the central and southern portions of the Site covering approximately 15% of the Site. Red Hook loam (Rh) is identified within the northwestern portions of the Site covering approximately 14% of the Site. Chenango gravelly silt loam, 0% to 3% slopes (CoA) is identified within the eastern portions of the Site covering approximately 7% of the Site. Halsey silt loam (Ha) is identified within the eastern and southern portions of the Site covering approximately 6% of the Site.

Holly silt loam soil is a very deep, poorly to very poorly drained soil that formed in loamy alluvium found on broad flat areas and in slight depressions on floodplains receiving alluvium from upland areas of low-lime drift and noncalcereous sandstone and shale (NRCS 2013). Solum thickness ranges from 20 to 44 inches and the average clay content ranges from 18% to 20% throughout the solum. This soil also features negligible to low surface runoff. Some areas have been cleared and used for pasture and cultivation. Many areas of this soil are used as natural areas for wetland wildlife habitat. Native vegetation consists of soft maple, elder, willow, and other trees tolerant of wet sites.

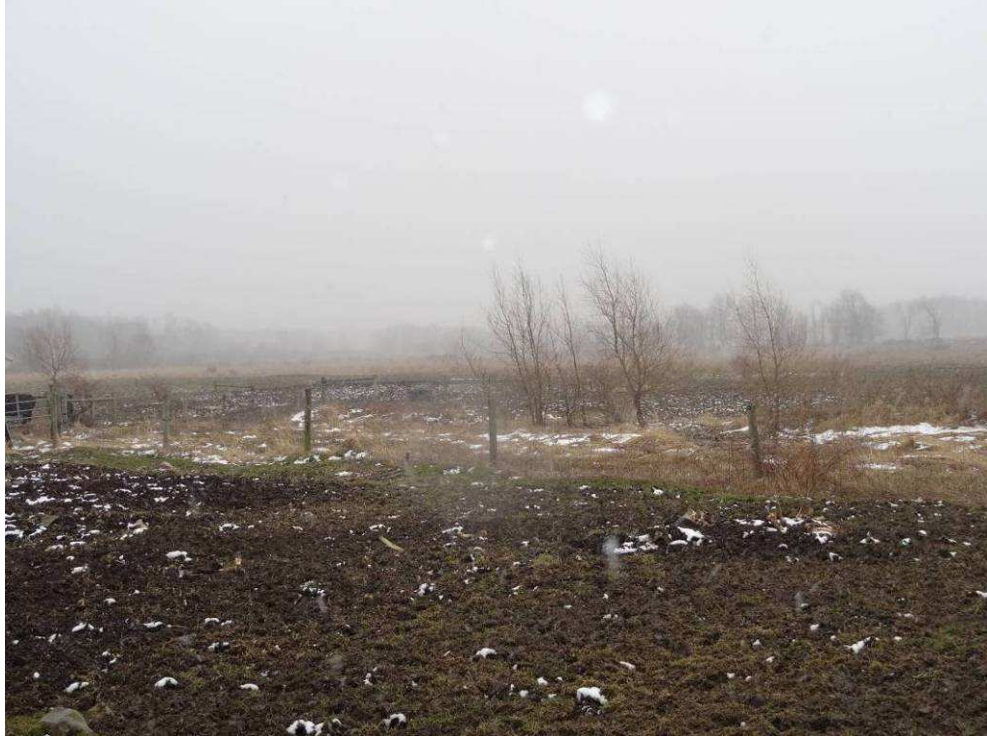
Plate. 1. View of Site along the north edge of the upland looking southeast. Note how area is churned from the extensive cattle traffic.
